Material Structure of Germanium-Doped Optical Fibers and Preforms

By H. M. PRESBY, R. D. STANDLEY, J. B. MacCHESNEY,
and P. B. O'CONNOR

The structural characteristics of preforms and optical fibers fabricated by modified chemical vapor deposition were studied by optical, interference, and scanning electron microscopy. It was observed that the structural features resulting from the deposition process are preserved through subsequent processing and appear in the fiber with the exception of a region at the center of the fiber. Here, selective evaporation of dopant material from the inner surface of the deposit results in a refractive index depression on the axis of the optical waveguide.

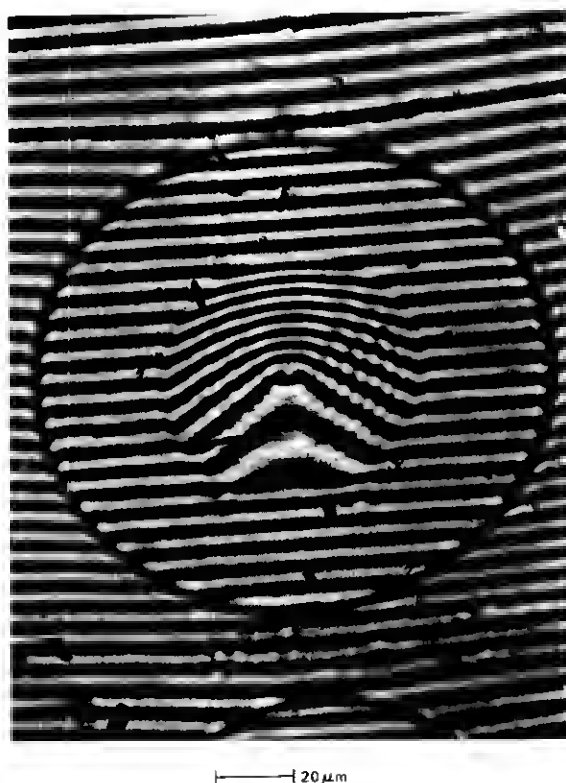
diameter, raised, tapered pip in the center. Note also the preservation of the distinct step and layer structure. The refractive index depression is also observed in this case in the microinterferogram of the fiber shown in Fig. 7. It is seen as a dip in the fringe normally passing through the center of the fiber. Slight modulations of the refractive index can also be observed at each of the ten steps in this case owing to the relatively large change in germanium concentration between the steps.

Fig. 7—Microinterferogram of linear refractive-index profile fiber showing index depression in center.
